# USCG FY2006 Grant *In-Water Shock Hazard Mitigation Strategies* Final Report October 1, 2008

**Authored by James D. Shafer and Capt. David E. Rifkin (USN, Ret)**

USCG FY2006 Grant  
*In-Water Shock Hazard Mitigation Strategies*

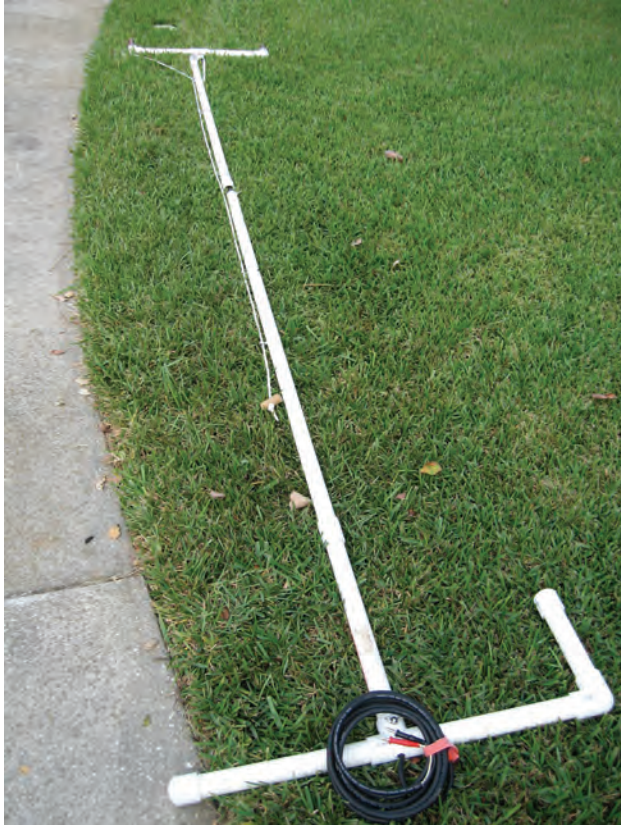
Complete Test Rig

- Voltage gradient measuring device ("Test Rig") with probes 2 feet apart (see photos at end of this section)
- Digital Voltmeter, Ideal Model 61-481
- Digital Current Leakage Tester, Ideal Model 61-452
- Circuit Tester, Ideal, Suretest Model 61-164
- Variac, Powerstat, Superior Electric Co., 900VA
- Conductivity, TDS, Temp, pH meter, Extech EC510
- Salinity tester, Hannah HI 98203
- Isolation transformer, Precision Electronics, Cat# 6634, 500VA
- Assorted cabling, plugs, receptacles, adapters
- Variable Ground Fault Protection Cable, Northshore Safety Systems

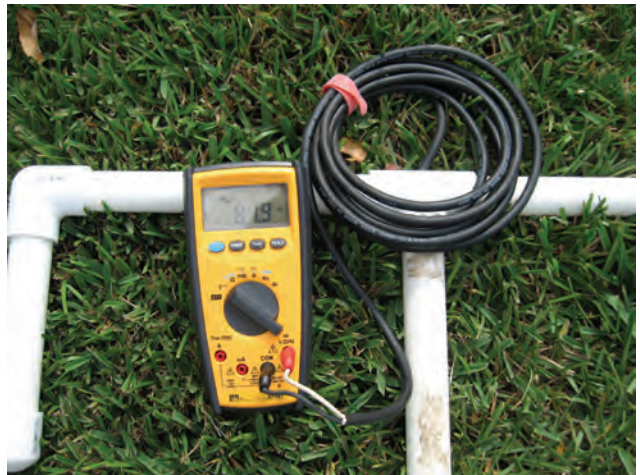
Meter connected to Test Rig probes

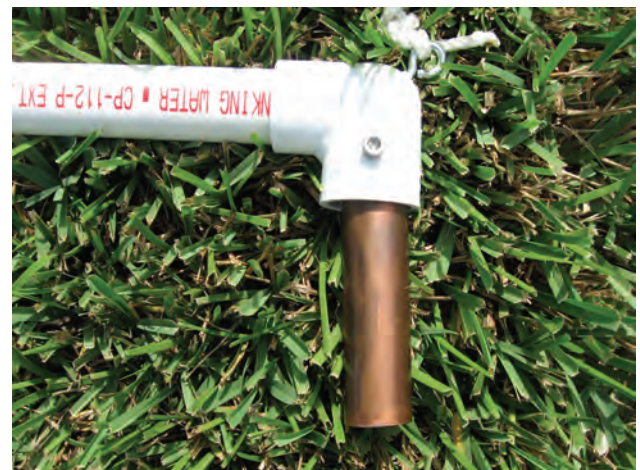
One of 2 copper probes on Test Rig

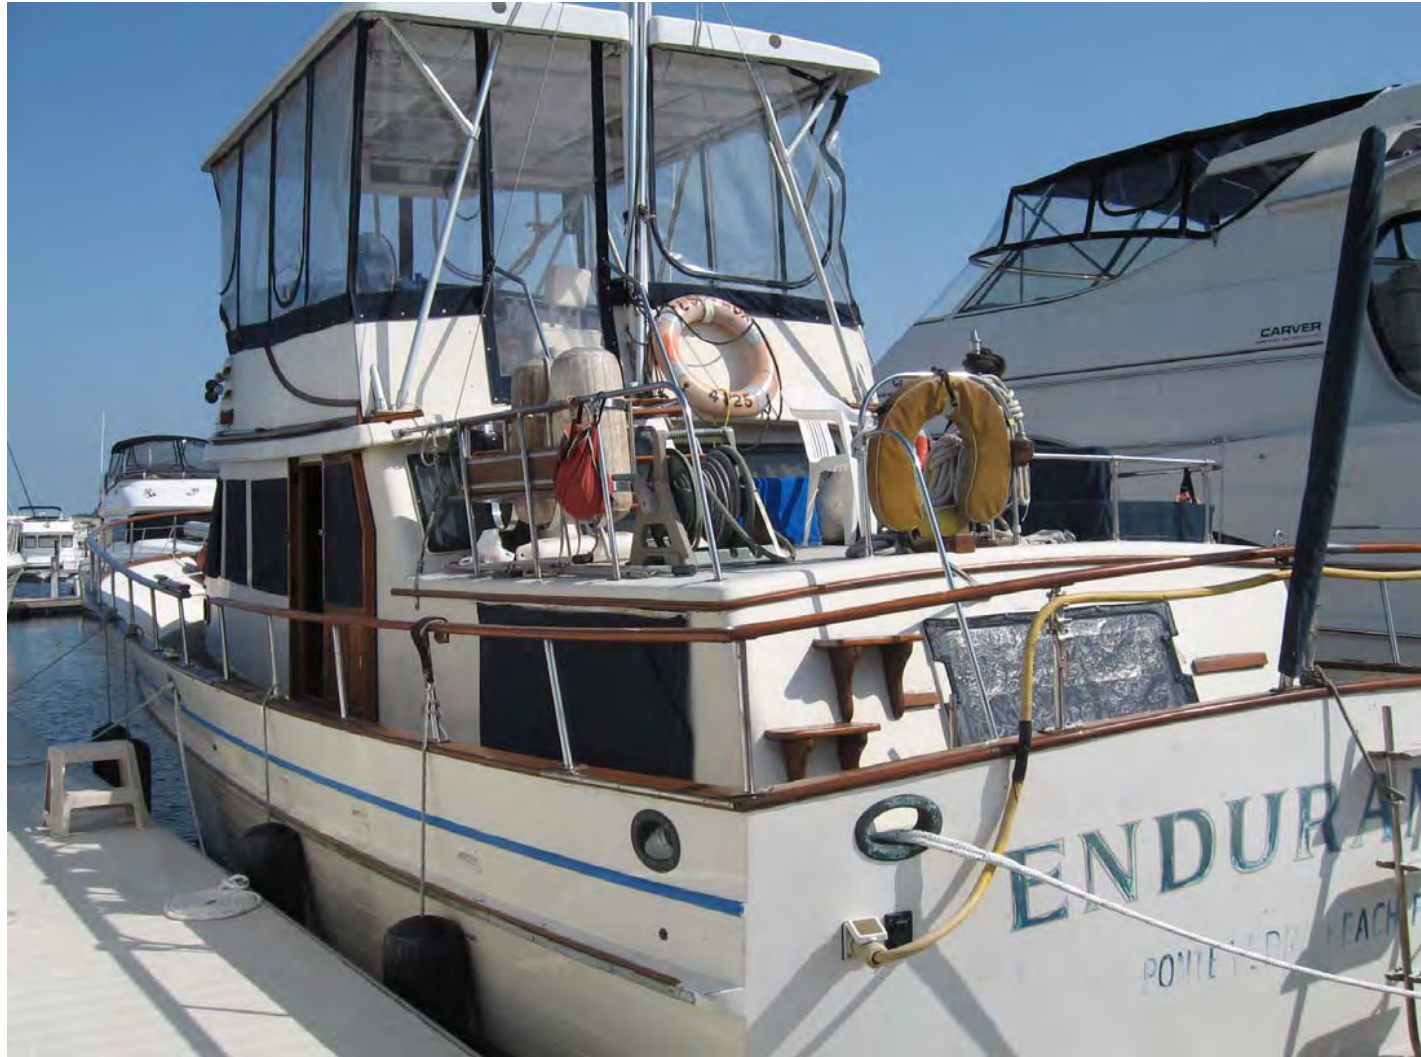
Endurance (Sheet 1-1-1,2)

1. Neutral and ground were connected on the boat. The boat was tested with shore cord removed so there was no interference from this connection.

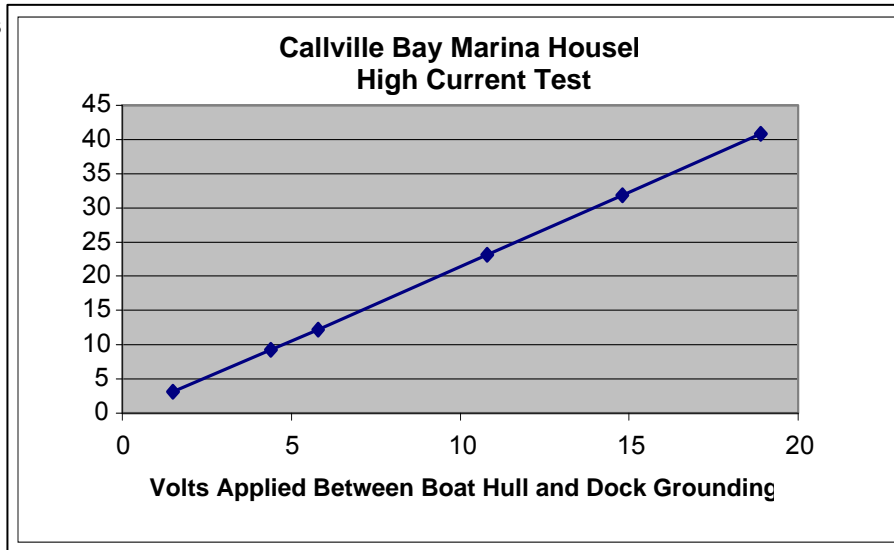
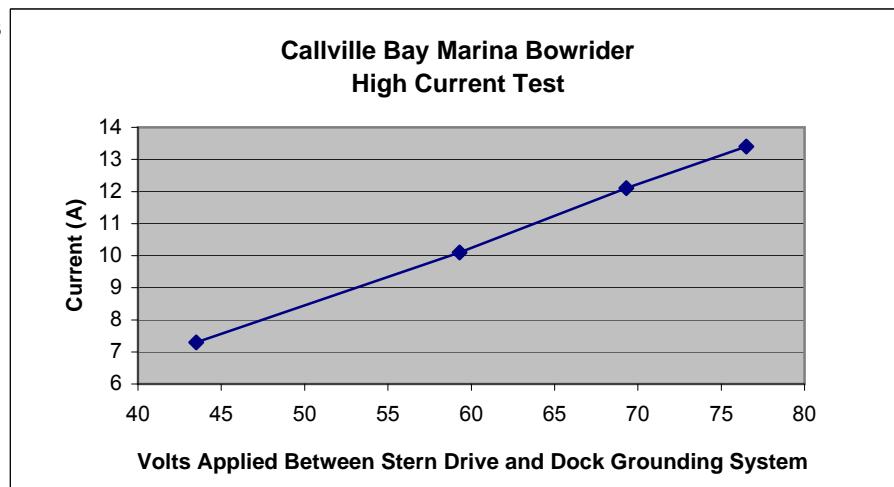
# Sheet 3A, CBM Linearity Data

Calville Bay Marina, 4/11/07. Voltage was applied to the hull (top) and outdrive (bottom) and the resulting water current measured.

Using the linear relationship between voltage and current, the current for any voltage can be extrapolated

Hull Volts	Water Amps
1.5	3.1
4.4	9.3
5.8	12.2
10.8	23.2
14.8	31.9
18.9	40.8

Hull Volts	Water Amps
43.5	7.3
59.3	10.1
69.3	12.1
76.5	13.4

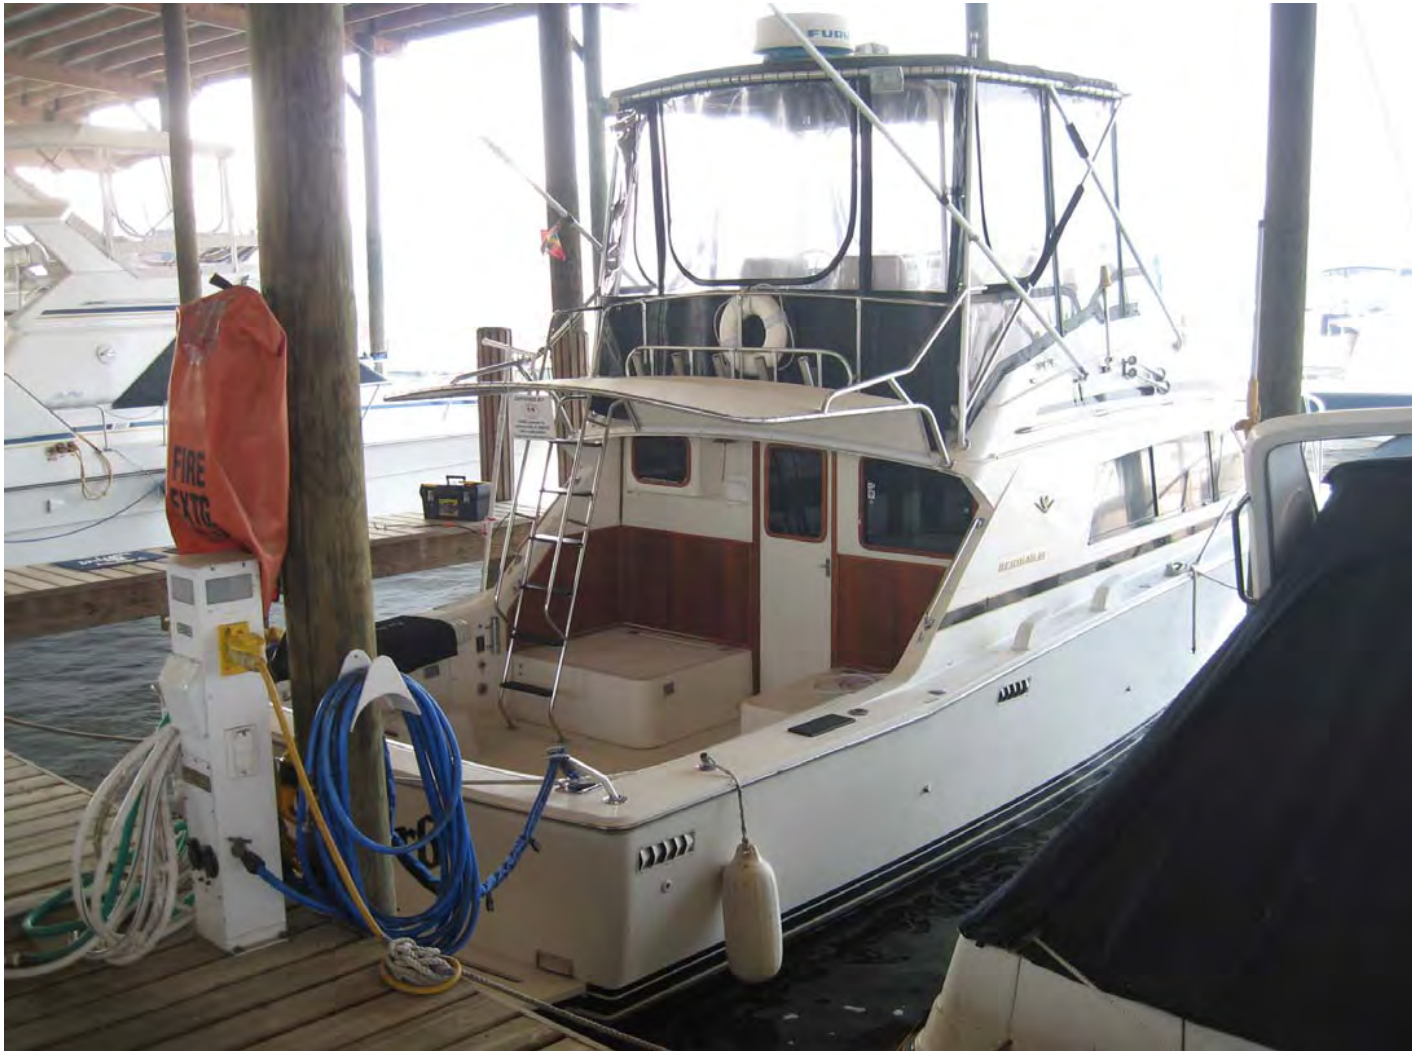
Lady Barb (Sheet 5-2-1,2)

Difference Voltages	1	2	3	4	5	6	7	8
HF1ft (V/ft)	0.009	0.015	0.042	0.072	0.065	0.108	0.038	0.015
HF3ft(V/ft)	0.009	0.015	0.044	0.064	0.072	0.091	0.045	0.010
HF5ft(V/ft)	N/A	N/A	N/A	N/A	N/A	N/A	N/A	N/A
V3ft(V)	0.230	0.326	0.726	0.796	0.871	0.811	0.500	0.283
VF3ft(V/ft)	0.009	0.015	0.044	0.064	0.072	0.091	0.045	0.010

Bonding system:  Intact Pedestal Impedances w/SureTest: H 0.16 N 0.12 G 0.4 ohms  
 Test Current: 3 A Voltage for Test Current 4.7 V Water Type:  Salt  Brackish  Fresh  
 Salinity: 2.7 g/l TDS: 3.8 ppt pH: 8.1 Temp: 64F  
 Conductivity: 5.4 ms/cm@1ft 5.44 ms/cm@3ft 5.35 ms/cm@5ft Water path (Ω): 1.57

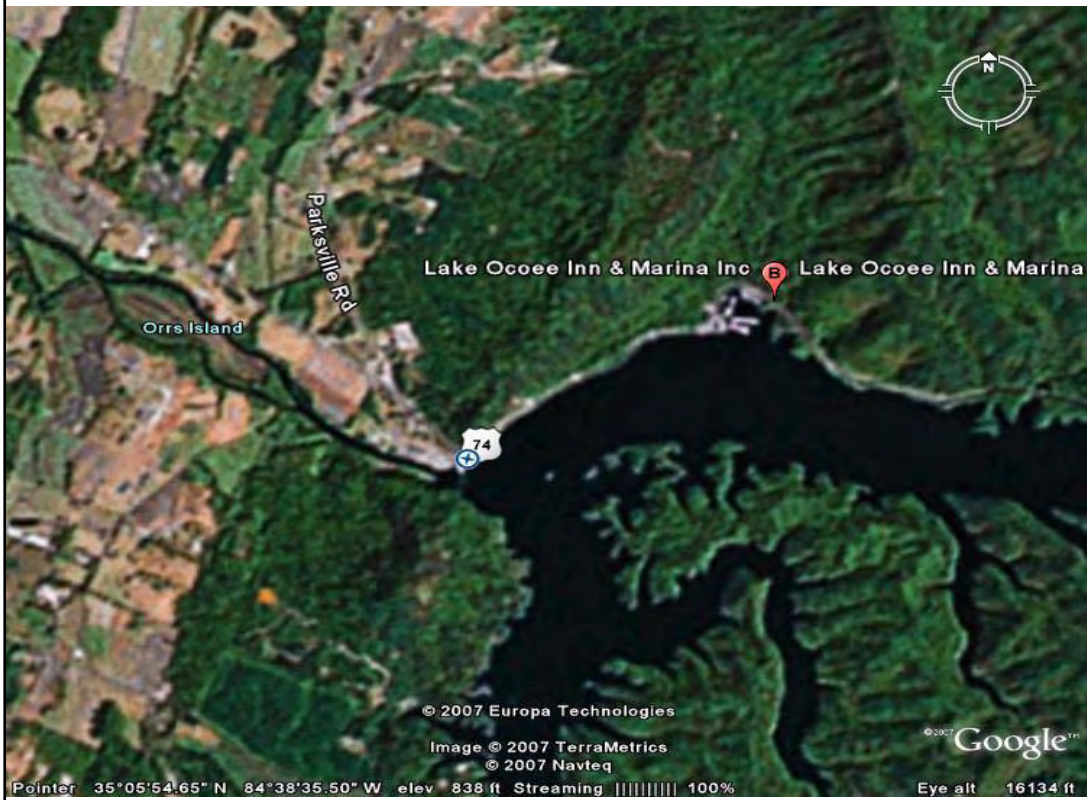
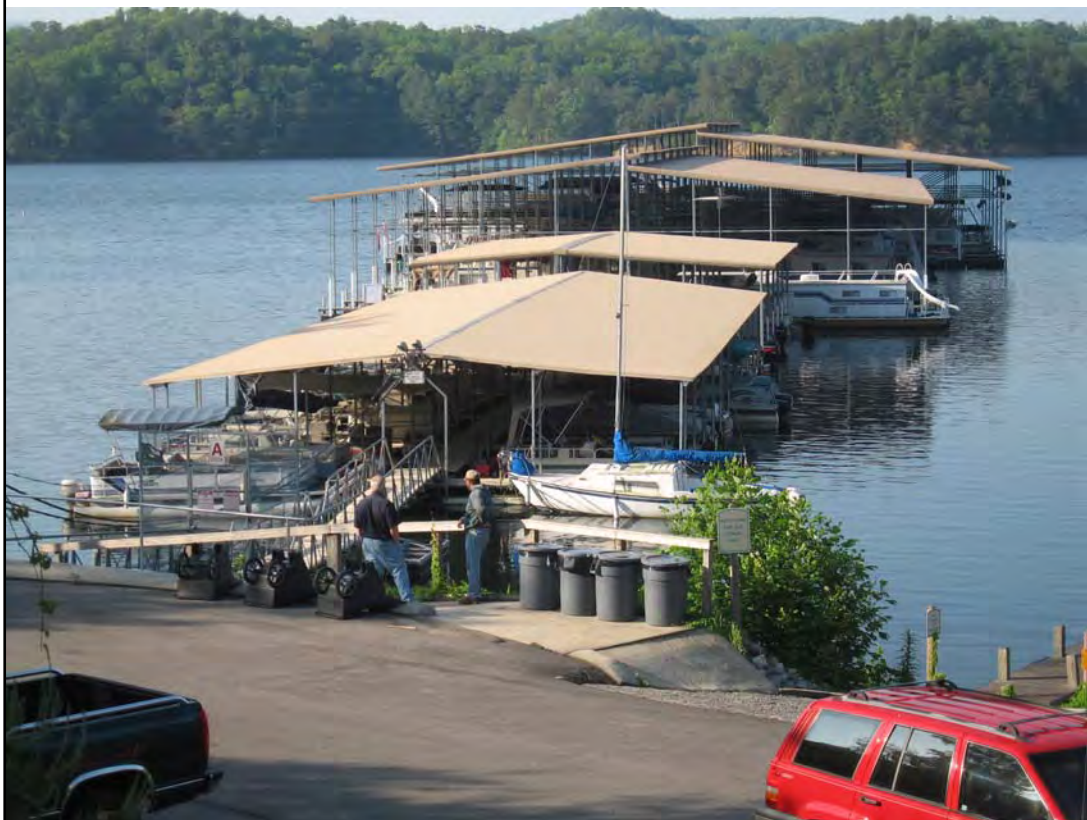
### Sheet 6-1-1, Field Strength/Voltage Data Form

Test number: LOM-FRP-IB-BI, 5/17/07, 0800 Date: 5/17/2007 Marina/Location Lake Ocoee Inn and Marina, Benton TN  
 Vessel Name: Diamond Jim Type: Houseboat Hull Material/Coating, if metal: FRP  
 Make/Model: 1979 Carcraft Dock #: A Slip #: 42 Pedestal #: 42 Water flow at dock: 0 kts  
 Mooring: **Wharf:**  S /  P Side to **Slip:**  Bow In/  Bow Out **Tee Dock:**  S /  P Side to  
 Length/Beam: 40'/12' ft **Prop:**  Inboard  Inboard Outboard  Outboard  Sail :  Single  Double  
 Power:  50A/240V  30A/120V  2-30A/120V  50A/240V to 2-30A Other:

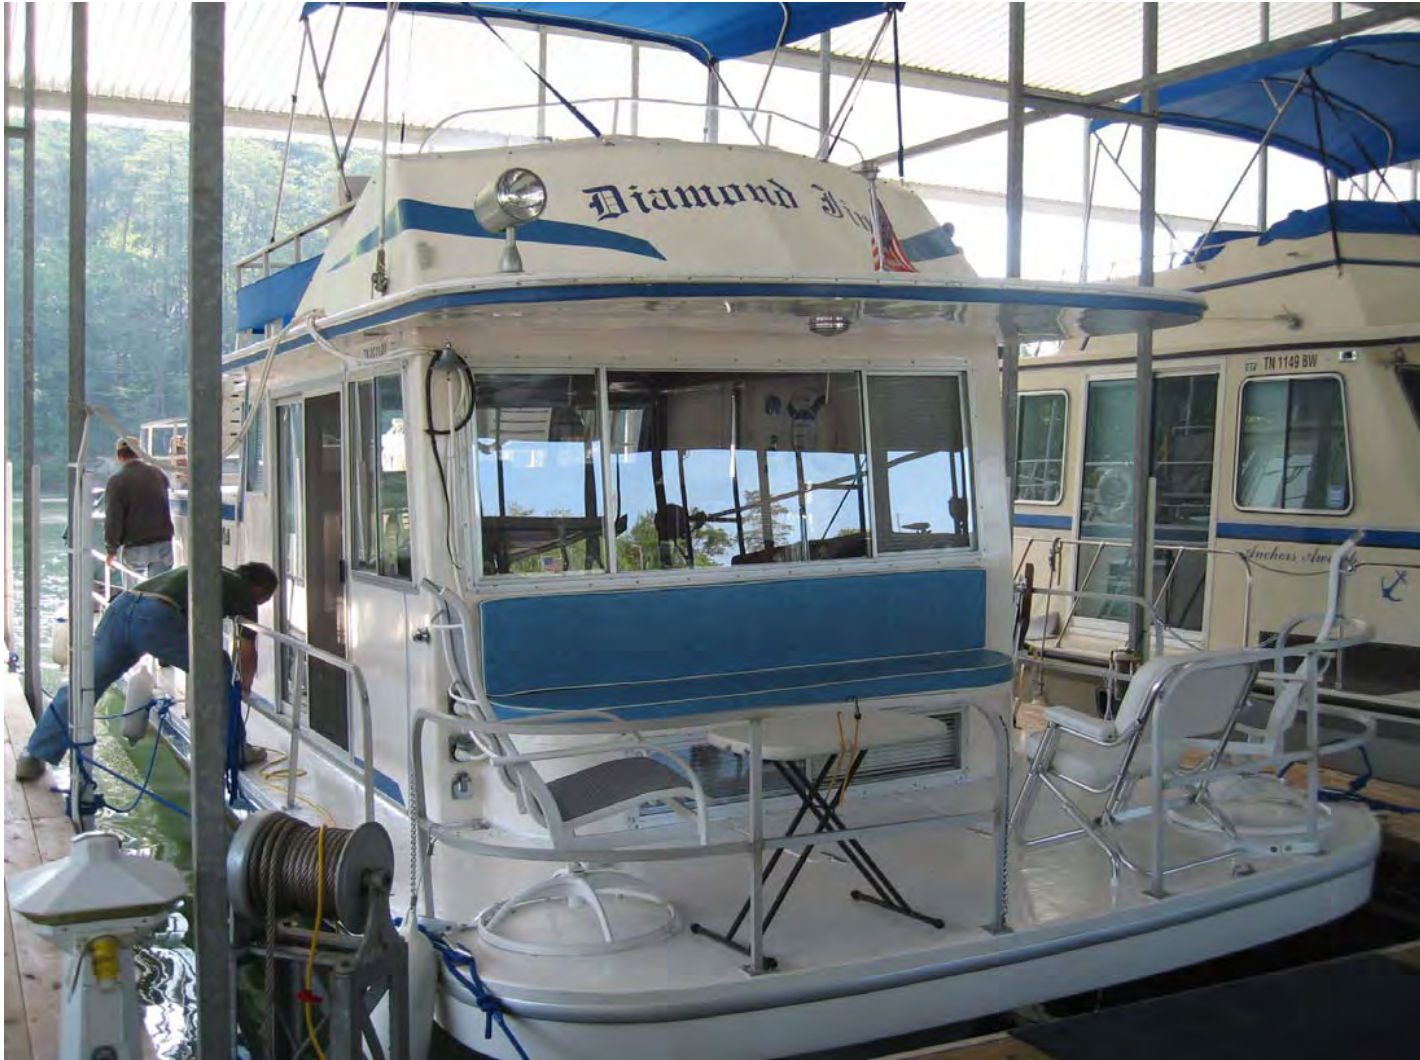
Diamond Jim (Sheet 6-1-1,2)

Difference Voltages	1	2	3	4	5	6	7	8
HF1ft (V/ft)	0.085	0.143	0.369	3.599	6.749	4.499	0.422	0.115
HF3ft (V/ft)	0.088	0.139	0.374	4.149	7.349	4.249	0.414	0.111
HF5ft (V/ft)	0.081	0.134	0.370	2.799	3.899	2.799	0.374	0.107
V3ft (V)	1.124	1.673	4.868	17.780	21.986	18.979	5.775	1.797
VF3ft (V/ft)	less	less	less	less	7.699	less	less	less

Bonding system:  Intact Pedestal Impedances w/SureTest: H 0.03 N 0.1 G 0.03 ohms  
 Test Current: 2.2 A Voltage for Test Current 117.5 V Water Type:  Salt  Brackish  Fresh  
 Salinity: 0.029 g/l TDS: 0.046 ppt pH: 8 Temp: 70F  
 Conductivity: 0.064 ms/cm@1ft 0.058 ms/cm@3ft 0.057 ms/cm@5ft Water path (Ω): 53.41

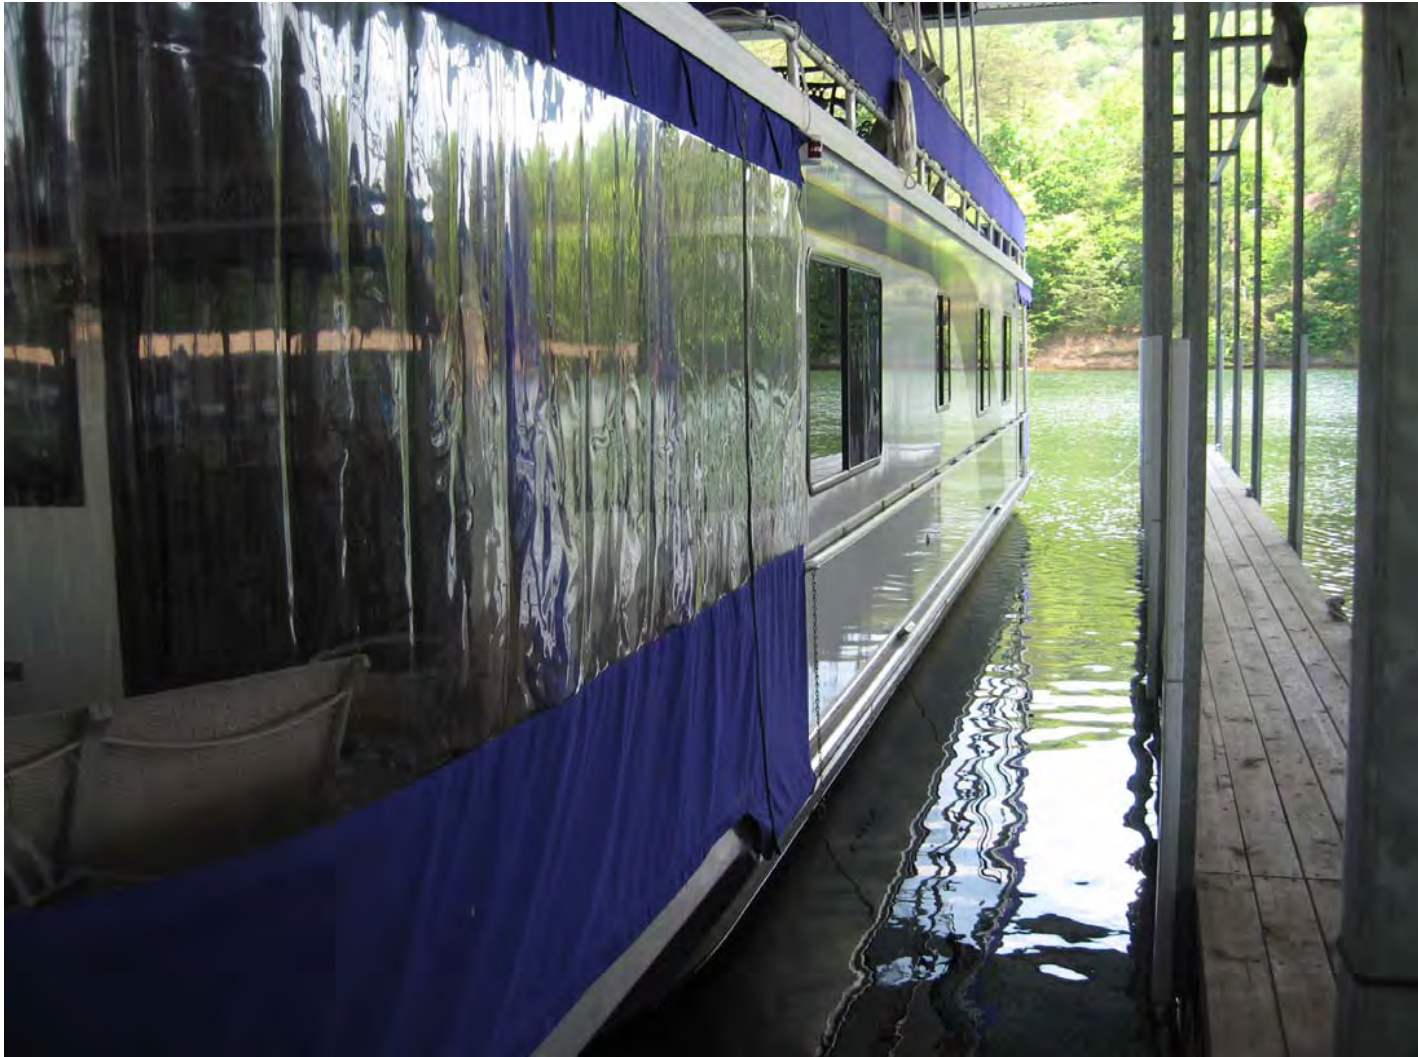
For Pete Sake (Sheet 6-2-1,2)

Difference Voltages	1	2	3	4	5	6	7	8
HF1ft (V/ft)	0.624	1.149	1.044	1.898	3.498	1.348	1.348	1.198
HF3ft(V/ft)	0.604	0.914	0.844	1.148	1.649	1.038	0.898	0.948
HF5ft(V/ft)	0.324	0.619	0.644	0.758	1.199	0.673	0.579	0.549
V3ft(V)	3.984	8.083	8.783	6.988	11.277	6.882	10.569	6.675
VF3ft(V/ft)	0.799	1.299	0.899	1.549	3.899	1.448	1.248	1.148

Bonding system:  Intact Pedestal Impedances w/SureTest: H 0.04 N 0.07 G 0.04 ohms  
 Test Current: 3 A Voltage for Test Current 22 V Water Type:  Salt  Brackish  Fresh  
 Salinity: 0.029 g/l TDS: 0.046 ppt pH: 8 Temp: 70F  
 Conductivity: 0.064 ms/cm@1ft 0.058 ms/cm@3ft 0.057 ms/cm@5ft Water path (Ω): 7.33

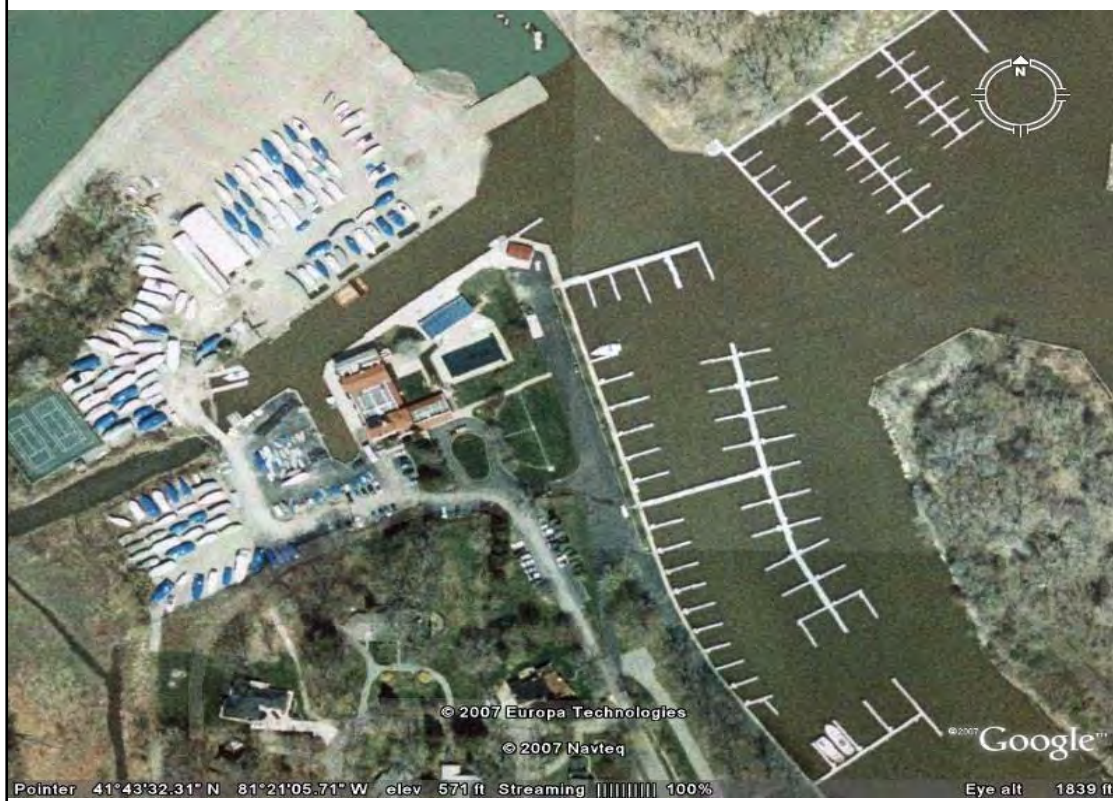
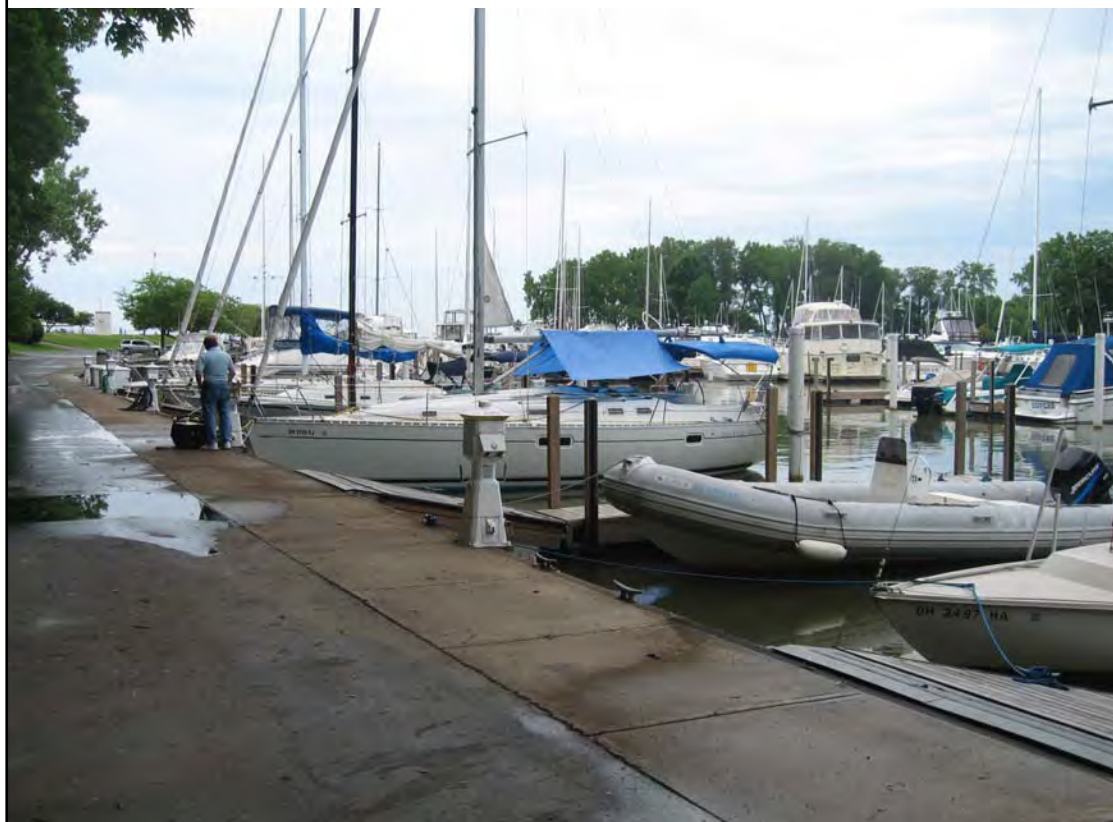
# Sheet 7-1-1, Field Strength/Voltage Data Form

Test number: MHY-FRP-IB-BI, 6-5-07, 0800hrs Date: 6/5/2007 Marina/Location Mentor Yacht Club, Lake Erie, Mentor OH

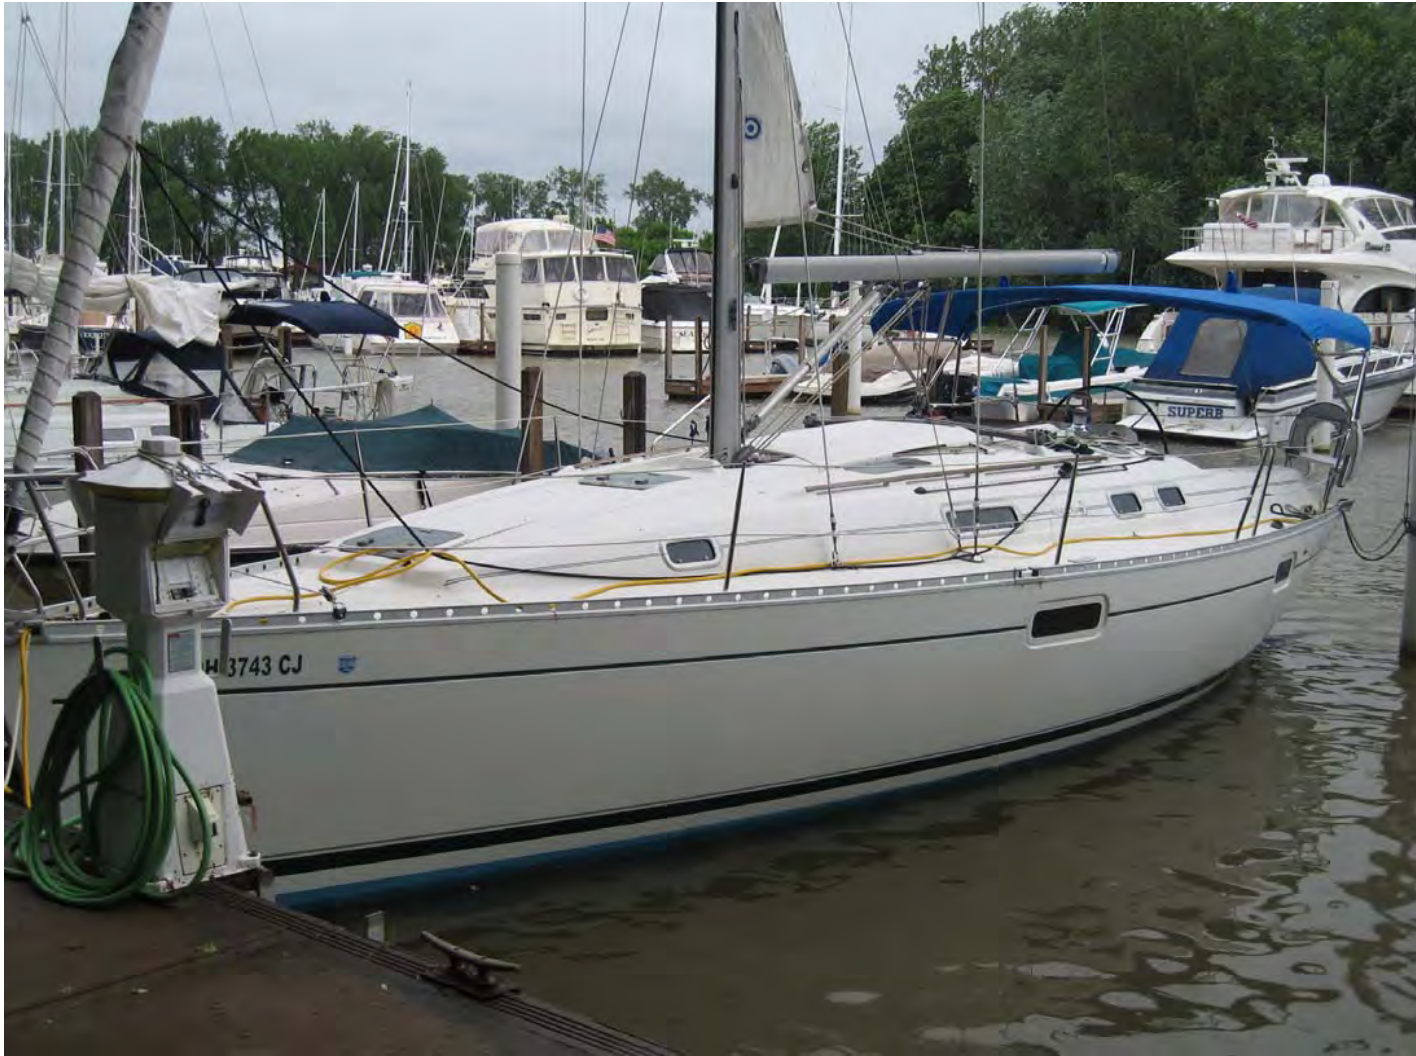
White Spray (Sheet 7-1-1,2)

Salinity: 0.501 g/l TDS: 0.696 ppt pH: 8.3 Temp: 70F

Conductivity: 0.999 ms/cm@1ft 0.999 ms/cm@3ft 1.01 ms/cm@5ft Water path (Ω): 5.30

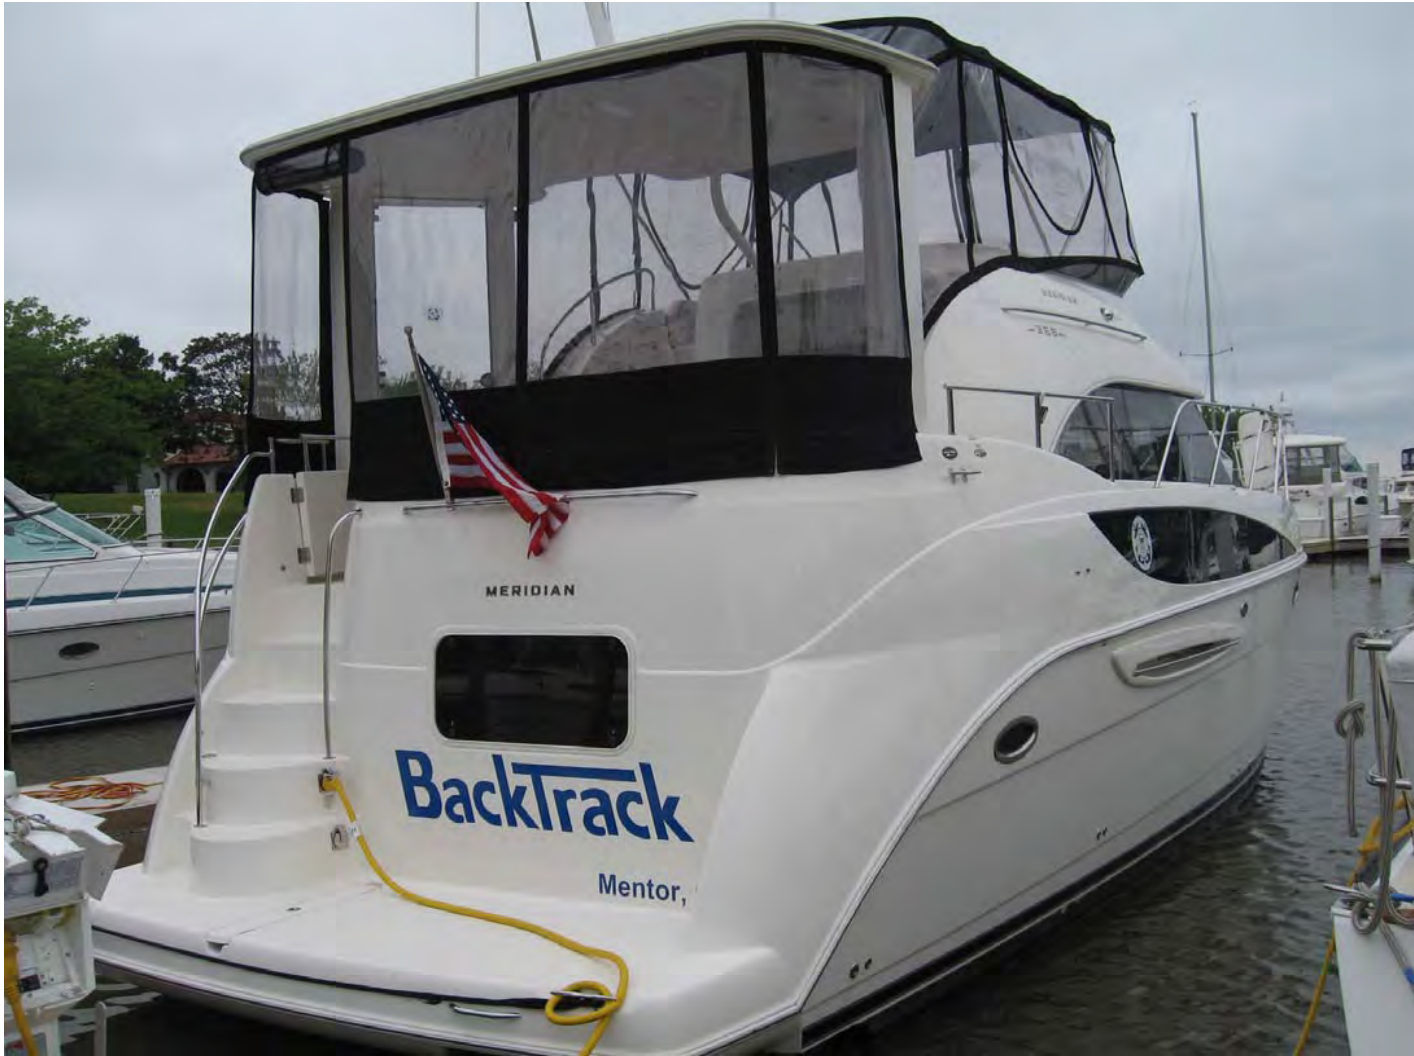
Back Track (Sheet 7-2-1,2)

Difference Voltages	1	2	3	4	5	6	7	8
HF1ft(V/ft)	0.030	0.053	0.096	0.224	0.319	0.274	0.100	0.044
HF3ft(V/ft)	0.029	0.053	0.101	0.264	0.300	0.359	0.109	0.049
HF5ft(V/ft)	0.030	0.052	0.100	0.209	0.217	0.210	0.102	0.052
V3ft(V)	1.083	1.370	2.253	3.020	2.781	2.708	1.880	1.340
VF3ft(V/ft)	less	less	less	less	0.334	less	less	less

Bonding system:  Intact Pedestal Impedances w/SureTest: H 0.04 N 0.08 G 0.08 ohms  
 Test Current: 3 A Voltage for Test Current 10.16 V Water Type:  Salt  Brackish  Fresh  
 Salinity: 0.501 g/l TDS: 0.696 ppt pH: 8.3 Temp: 70F  
 Conductivity: 0.999 ms/cm@1ft 0.999 ms/cm@3ft 1.01 ms/cm@5ft Water path (Ω): 3.39

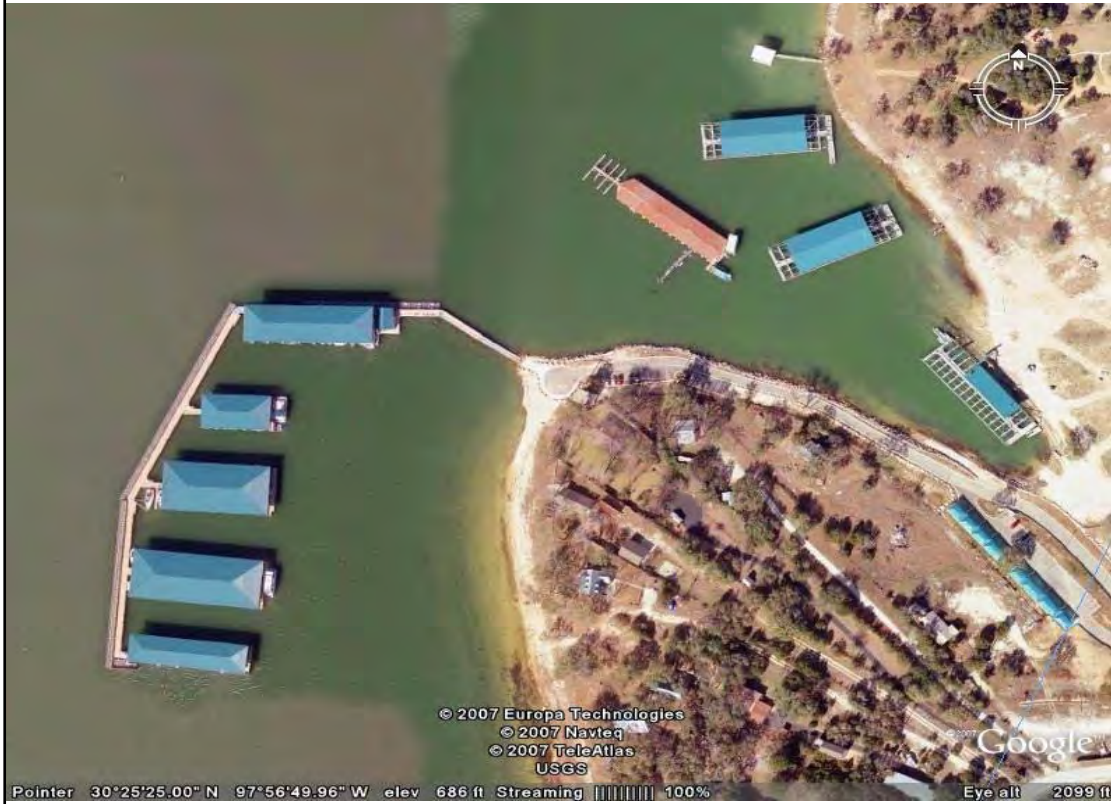
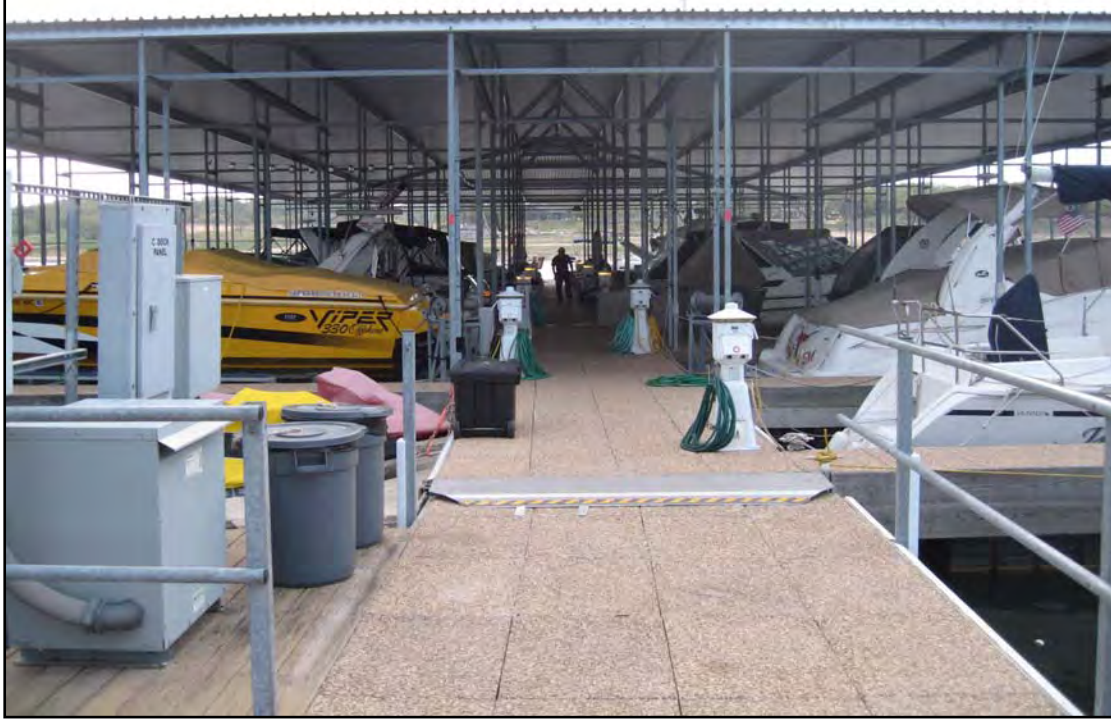
### Sheet 8-1-1, Field Strength/Voltage Data Form

Test number: PCM-FRP-IB-BO, 3-29-07 0800hrs Date: 3/29/2007 Marina/Location: Paradise Cove Marina/Dallas TX  
 Vessel Name: Texas Martini Type: Cruiser Hull Material/Coating, if metal: FRP  
 Make/Model: SeaRay Sundancer 240 Dock #: C Slip #: C9 Pedestal #: C9 Water flow at dock: 0 kts  
 Mooring: **Wharf:**  S /  P Side to **Slip:**  Bow In /  Bow Out **Tee Dock:**  S /  P Side to  
 Length/Beam: 34/10' ft **Prop:**  Inboard  Inboard Outboard  Outboard  Sail :  Single  Double  
 Power:  50A/240V  30A/120V  2-30A/120V  50A/240V to 2-30A Other:

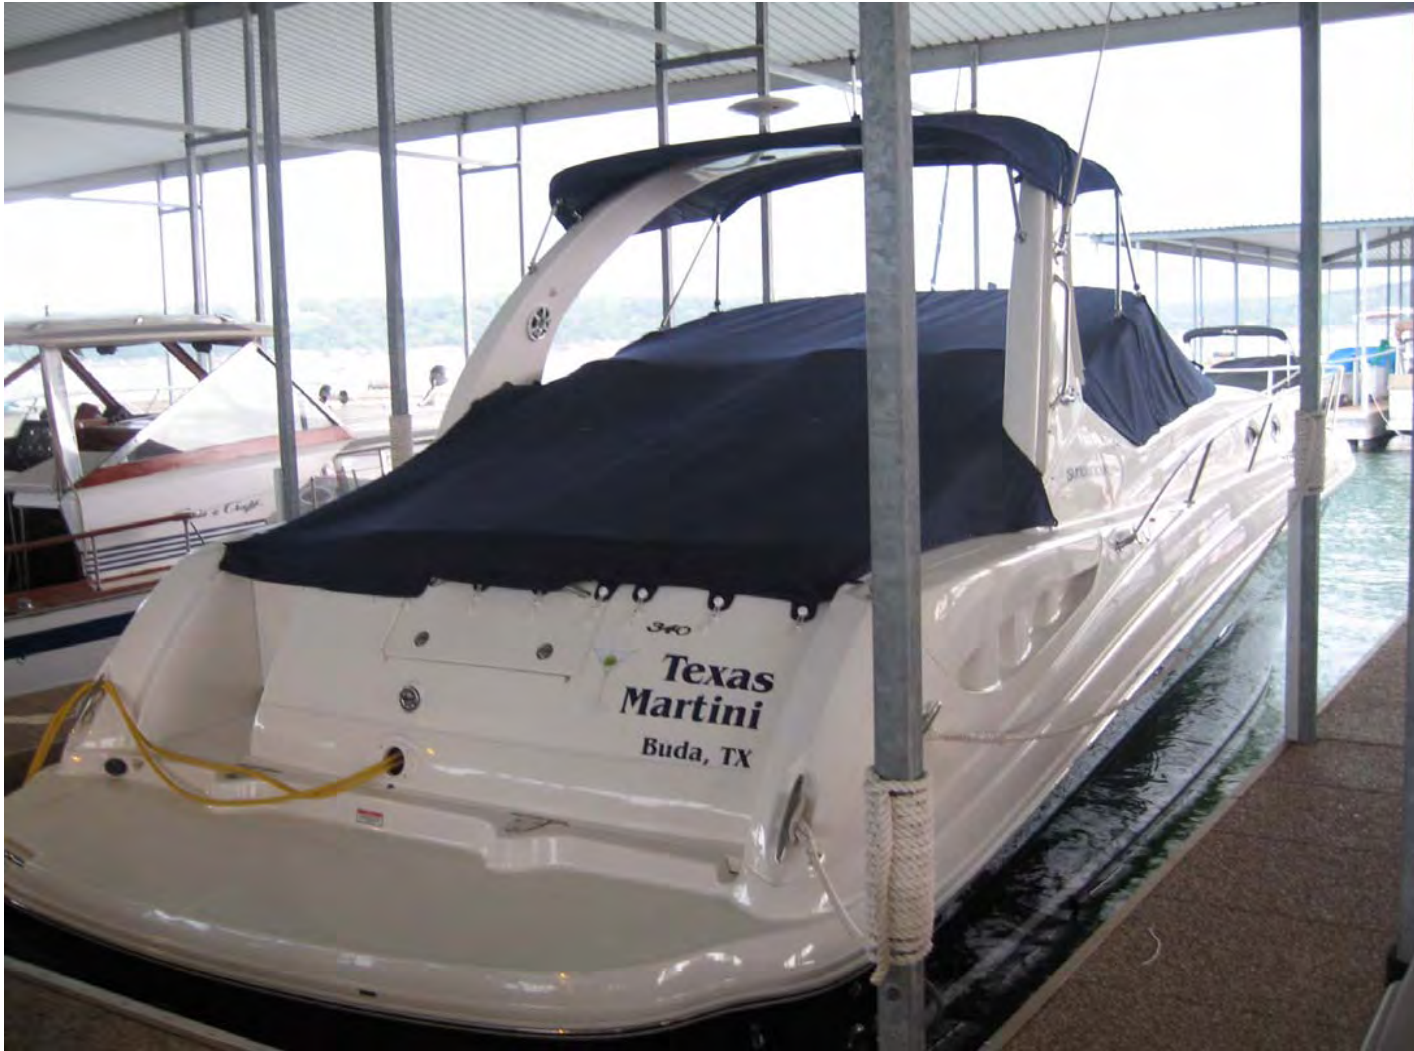
Texas Martini (Sheet 8-1-1,2)

Difference Voltages	1	2	3	4	5	6	7	8
HF1ft(V/ft)	0.006	0.051	0.114	0.664	1.249	0.539	0.124	0.058
HF3ft(V/ft)	0.004	0.054	0.107	0.609	0.999	0.534	0.114	0.060
HF5ft(V/ft)	0.001	0.059	0.106	0.446	0.594	0.379	0.105	0.063
V3ft(V)	0.142	0.387	1.295	3.297	3.889	2.805	1.232	0.196
VF3ft(V/ft)	0.004	0.054	0.107	0.609	0.999	0.474	0.114	0.060

Bonding system:  Intact Pedestal Impedances w/SureTest: H 0.05 N 0.04 G 0.08 ohms  
 Test Current: 3 A Voltage for Test Current 19 V Water Type:  Salt  Brackish  Fresh  
 Salinity: 0.237 g/l TDS: 0.333 ppt pH: 8.6 Temp: 67  
 Conductivity: 0.462 ms/cm@1ft 0.452 ms/cm@3ft 0.447 ms/cm@5ft Water path (Ω): 6.33

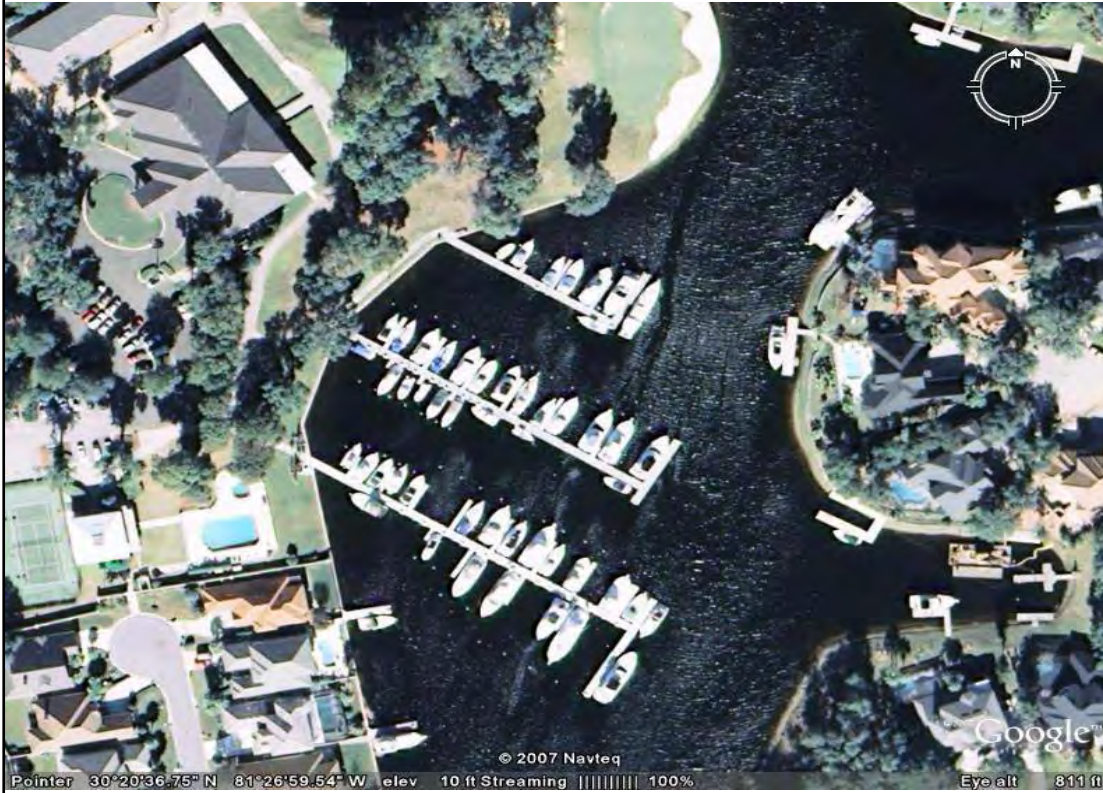
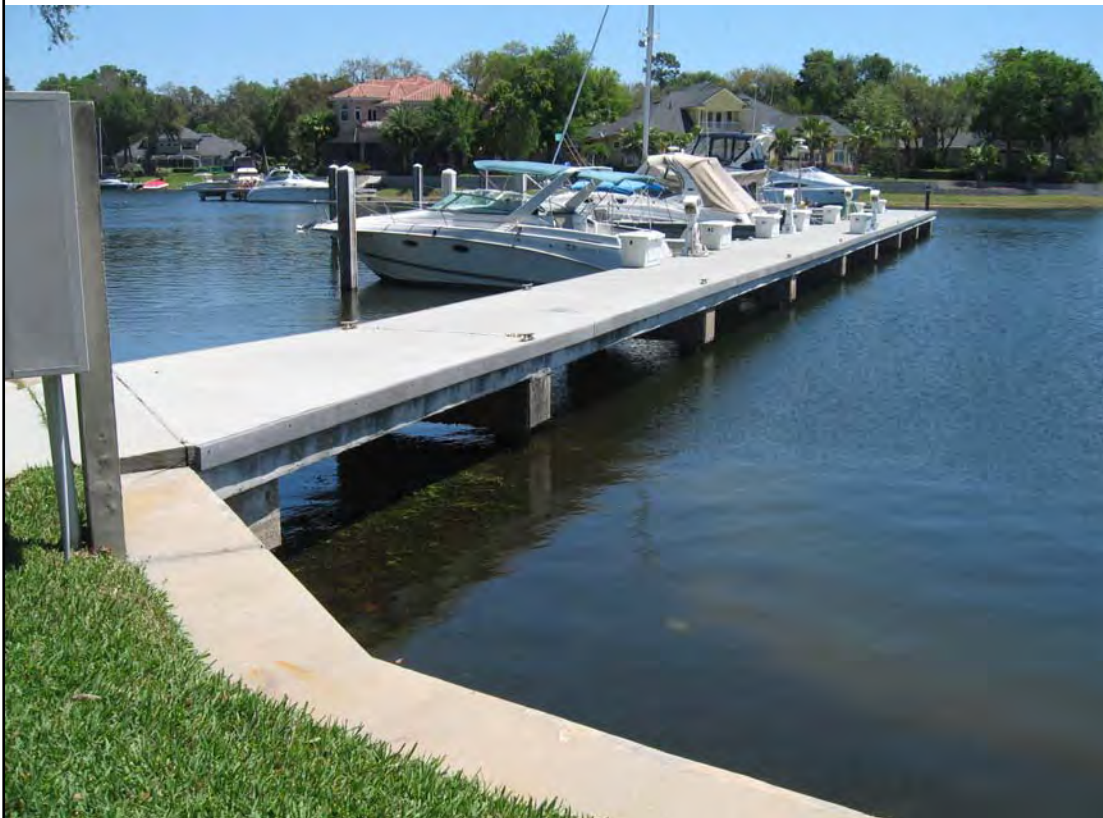
### Sheet 9-1-1, Field Strength/Voltage Data Form

Test number: QHA-FRP-IB-BO, 4-16-07, 1200 Date: 4/16/2007 Marina/Location Queens Harbor Marina, Jacksonville, FL  
 Vessel Name: Total Blarney Type: Cruiser Hull Material/Coating, if metal: FRP  
 Make/Model: Carver 370, 1995 Dock #: 1 Slip #: north end Pedestal #: N/A Water flow at dock: 0 kts  
 Mooring: **Wharf:**  S /  P Side to **Slip:**  Bow In/  Bow Out **Tee Dock:**  S /  P Side to  
 Length/Beam: 37'/13' ft **Prop:**  Inboard  Inboard Outboard  Outboard  Sail :  Single  Double  
 Power:  50A/240V  30A/120V  2-30A/120V  50A/240V to 2-30A Other:

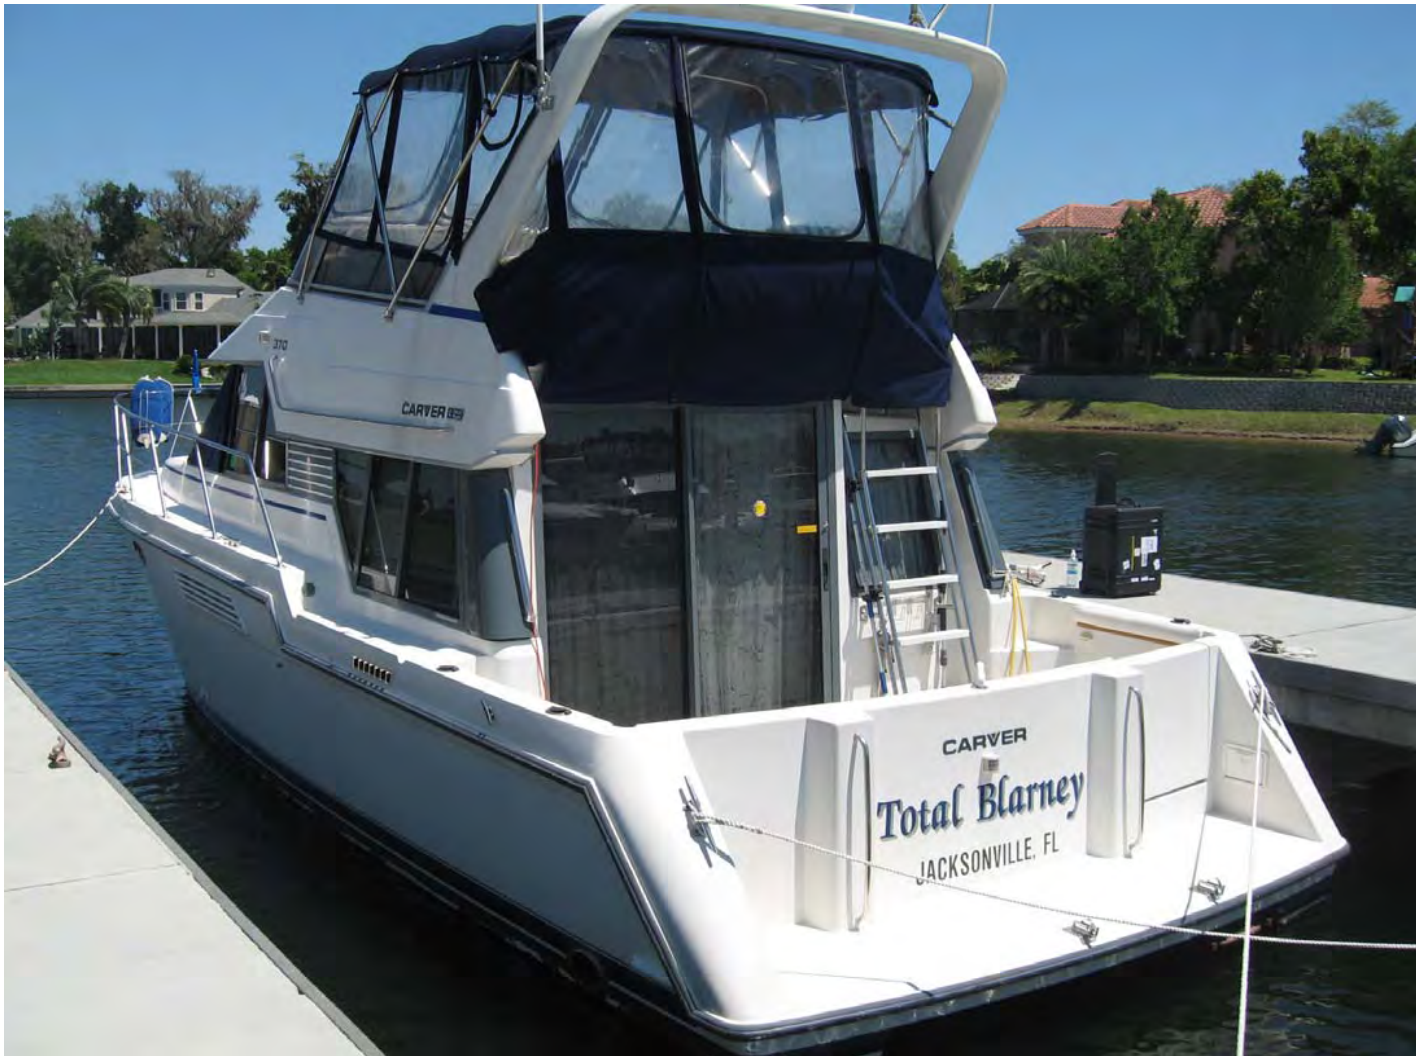
Total Blarney (Sheet 9-1-1,2)

Difference Voltages	1	2	3	4	5	6	7	8
HF1ft(V/ft)	0.001	0.002	0.004	0.009	0.013	0.008	0.004	0.002
HF3ft(V/ft)	0.001	0.002	0.004	0.008	0.010	0.008	0.004	0.002
HF5ft(V/ft)	0.001	0.001	0.003	0.009	0.007	0.006	0.004	0.002
V3ft(V)	0.263	0.272	0.312	0.360	0.317	0.279	0.287	0.272
VF3ft(V/ft)	less	less	less	less	less	less	less	less

Bonding system:  Intact Pedestal Impedances w/SureTest: H 0.22 N 0.08 G 0.34 ohms  
 Test Current: 3 A Voltage for Test Current 4.17 V Water Type:  Salt  Brackish  Fresh  
 Salinity: 24 g/l TDS: >20 ppt pH: 8 Temp: 72F  
 Conductivity: 19.8 ms/cm@1ft 19.5 ms/cm@3ft 19.7 ms/cm@5ft Water path (Ω): 1.39
